Black Butte Mine Tailings Identification

Prepared by Bryn Thoms, R.G. Oregon DEQ

May 22, 2012

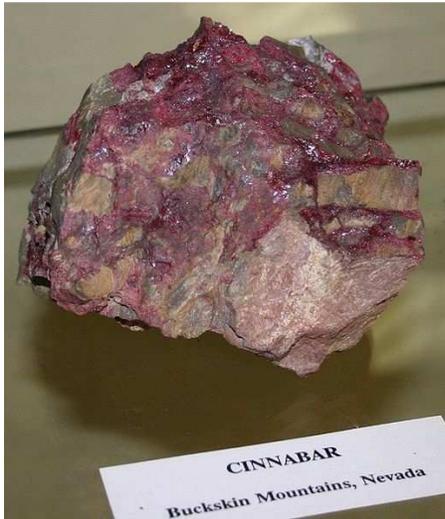
Figure 1 – Fresh cinnabar (mercury ore), from a Nevada mine. This is very similar to the type of ore once present at the Black Butte Mine. Notice the deep red color of the mineral cinnabar near the top. The lower portion of the grain has a lighter, more pink color, which is similar to the color found in Black Butte Mine tailings.

Freshly mined mercury ore, cinnabar, is generally much redder in color than the roasted ore. Unprocessed cinnabar is presented in Figure 1. Cinnabar is first crushed and roasted at 700 to 1000 ° F in order to pull off mercury vapor, which is later condensed into liquid mercury. The roasted ore (tailings) is then dumped on site near the milling area. Generally ore is crushed to about 1" minus, although depending on the age of the milling operation and the type of furnace, there could be a variety of crushing sizes. Roasted ore is lighter in color than the uncooked ore, yet it still retains some of the color banding that is common with these types of mercury ore deposits in the Western US.

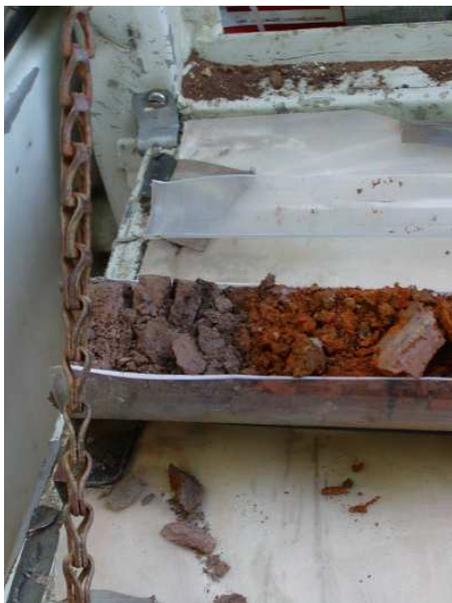
Figure 2 – BBM tailings vs. native soil. The picture represents about 5 inches of a core sample that was collected at depth in a tailings pile at BBM. On the right side of the core section are BBM tailings which are red and slightly banded. The left side of the color change in the core sample is native soil (silt with organics) which is brown and much less red.

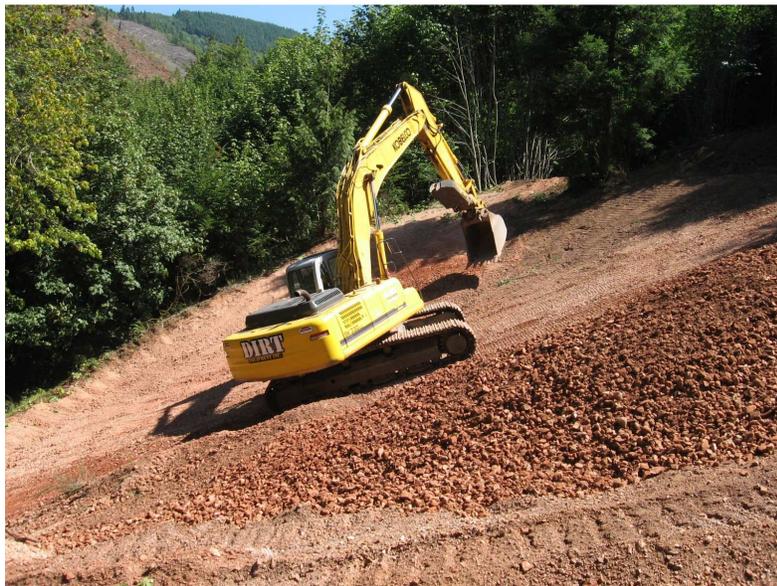
Figure 3 – Tailings from the main tailings pile at BBM – At closer inspection, the material is pinkish with light color banding, friable/crumbly, and more weathered-looking than fresh ore. This photo was taken during the EPA Removal Action in 2007.

As mentioned above, the grain size can vary. At BBM, the large end of the grain size spectrum is about 1.5", but generally the grain size range is about 1" minus. The material tends to be very angular due to crushing during the milling process and tends to have a larger fines fraction than the original ore, due to weathering. Figure 2 presents BBM tailings from a sample collected from the bottom of one of the tailings pile. Figure 3 presents a fresh surface of the BBM main tailings pile during the EPA Removal in 2007.

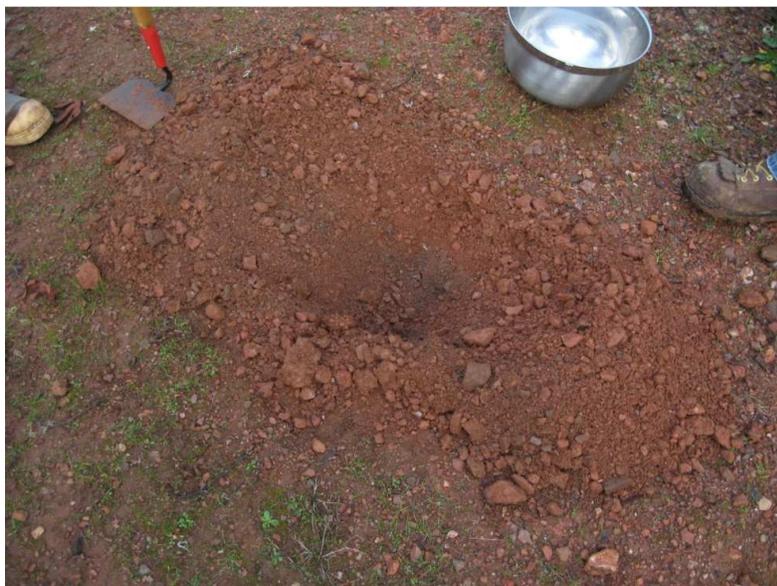
Figure 4 – Surface of RRR during sample collection in 2009. Notice the more homogenous appearance in color, less banding, and also the fine-grained nature of the material.

According to the Unified Soil Classification System (USCS), which is predominantly used for identification of soils/gravels for construction purposes, BBM tailings would be classified as a Well Graded Gravel (GW) or a Well Graded Gravel with Silt (GM). Well graded means that there is a variety of grain sizes ranging from greater than ¾" down to silt size particles. An individual silt particle is almost not visible to the human eye. There may be more fines (silts and clays) depending on the amount of weathering, but generally the fines tend not to exceed 10%. The surface of RRR is a good example of how the material will weather if it's used for road construction and exposed to the weather and traffic. Roasted ore is not a very strong rock and thus it breaks down with both continued mechanical and chemical weathering (e.g. vehicular traffic, freezing temperatures, rain). Figures 4 and 5 present photo's of RRR. Notice that the banding is much less apparent in weathered tailings.

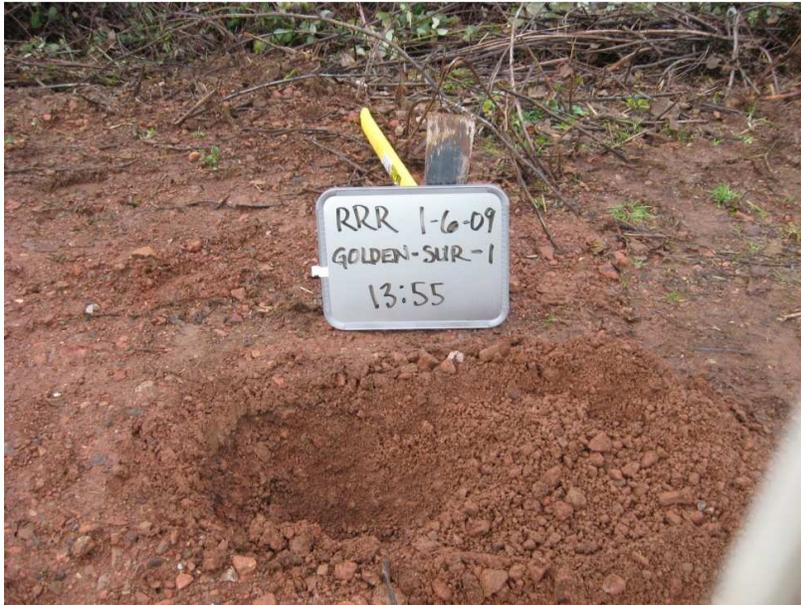
Figure 5 – Surface of RRR during sample collection in 2009. Again, notice the more homogenous appearance in color, less banding, and also the fine-grained nature of the material.
